SEEPAGE CUT-OFF WALL INSTALLATION USING CUTTER SOIL MIXING FOR HERBERT HOOVER DIKE REHABILITATION

Michael Arnold, BAUER Foundation Corp., Odessa, Florida, USA, (727) 531-2577,
marnold@bauerfoundations.com

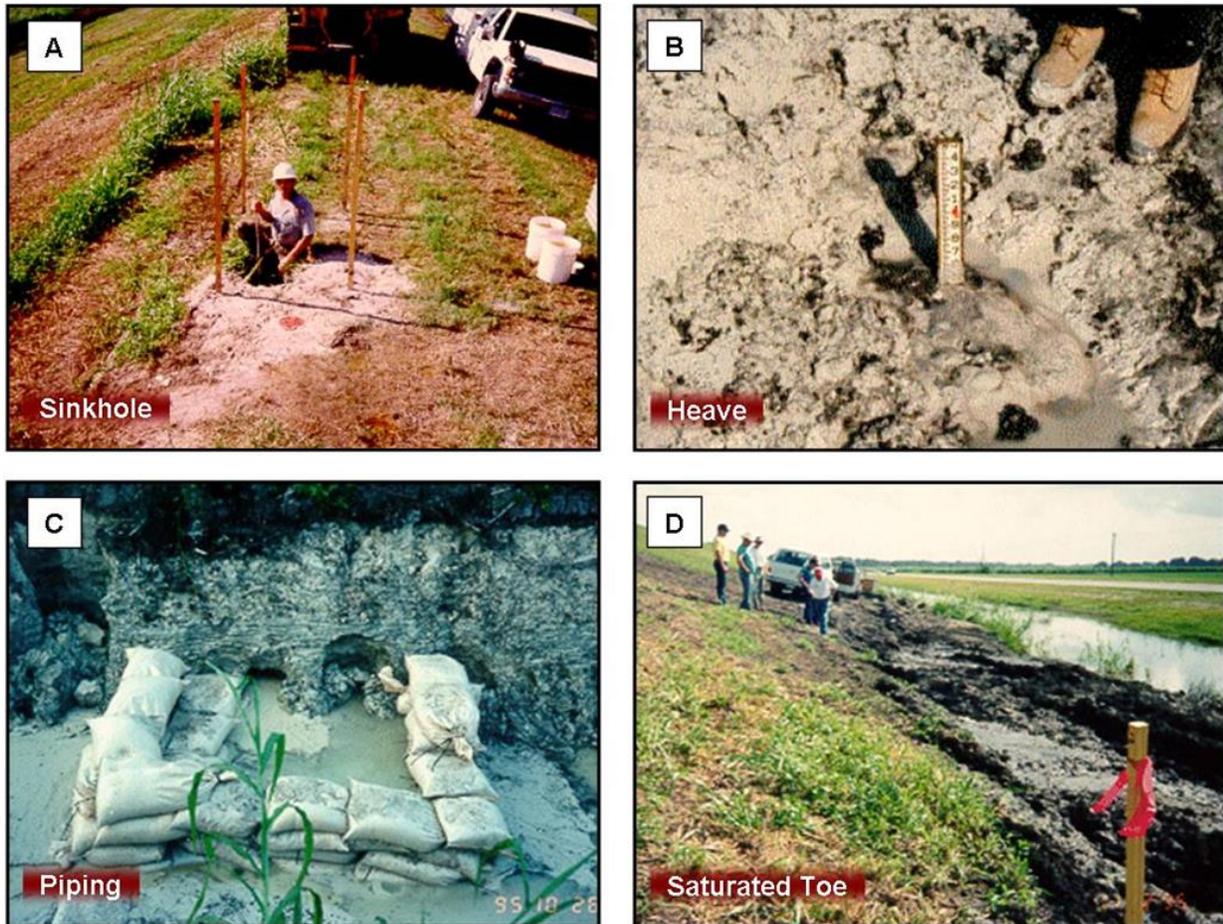
Figure 1: Types of observed dike damage: (A) Sinkhole formation in crest, (B) heave of downstream toe, (C) piping at downstream toe of dike, and (D) saturated soils at the ground surface of landward toe (Toe Ditch in Fig. 2) and embankment slope (from Davis et al. 2009).

The Herbert Hoover Dike is a 143-mile-long dike encircling Lake Okeechobee in south central Florida. When it was constructed in the 1930s and 1960s, the purpose of Herbert Hoover Dike was flood protection from hurricanes. However, during the 1970s a higher lake level was maintained permanently to provide local agriculture with water. Later, damage became apparent during two nearly back-to-back high water events in the 1990s, when numerous sink holes, seeps, pipes, and boils were observed (Fig. 1). In 2000, the Congress approved USACE to propose rehabilitation measures. The installation of a cut-off wall into the existing dike was chosen during the initial design process as the preferred measure to improve the safety of the dike (Davis et al. 2009).

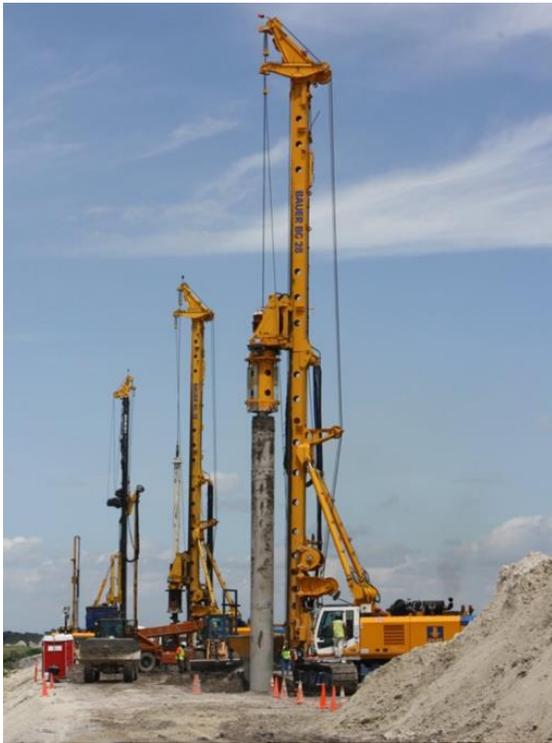
Figure 3: Two BAUER BG28 rigs (in front) drilling replacement columns (Arnold et al. 2011).

replacement columns. The excavated soils were classified as organic or non-organic based on visual inspection by the operator and placed on separate piles next to the rig. The geologist supervised the operator in his decision-making. The non-organic material was blended with locally imported fine sand by running both materials over a portable vibrating screen. This blended material was dumped into the open casing using a funnel for backfill. Excavated materials classified as organic could not be used as backfill, and were stockpiled and later recycled for dike restoration. This beneficial use of the excavated organic materials reduced transport and disposal costs. Replacement columns were typically carried out by two teams per CSM operation. Each team used a BAUER BG 28 or BAUER BG 40 drill rig with two sets of casing (Fig. 3).

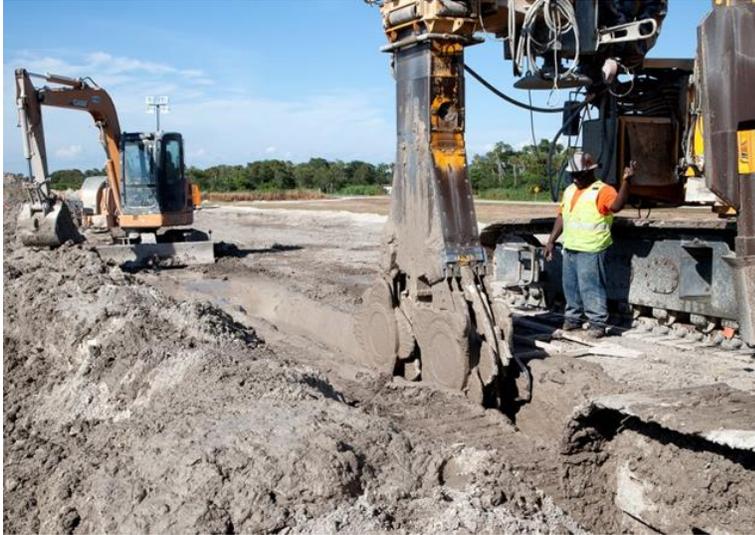
Figure 4: CSM tool BCM 5 being positioned over the pre-excavation trench.

The BCM 5 cutter head (Fig. 4) mounted on a RTG RG 25 S or BAUER BG 28 base rig via a rigid rectangular Kelly bar (Mono Kelly) was used to install the cut-off wall panels. All rigs used were equipped with an on-board computerized monitoring and controlling *B-Tronic* system. This system allows the operator to control verticality during panel installation, and to control the slurry volume pumped by depth. It is also used for quality control purposes as it documents the entire panel installation process.

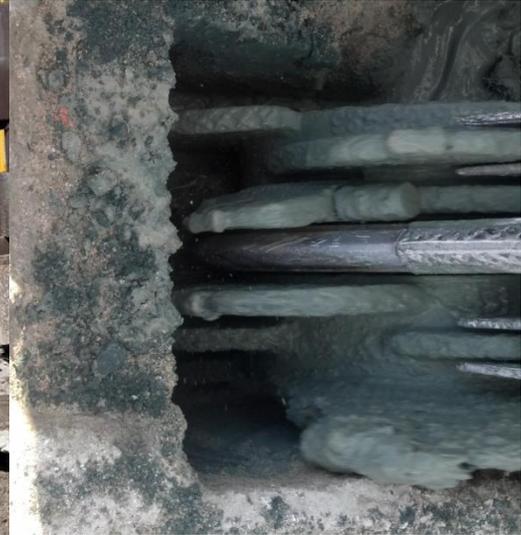
Figure 5: Rough interface created by the CSM tool overcutting a hardened panel.

The mix design of the slurry included water taken from Lake Okeechobee, slag cement, type II Portland cement, bentonite, and retarding agent. Slag cement was used for two reasons: it causes delayed set, and shows a slower strength evolution. First, applying the single phase system as described above, the mix must not reach initial set until the tool is safely out of the ground. Second, the delay is also beneficial for the few cold joints created after weekend breaks. The slow hardening process during the first days allows the panels installed before and after the break to "grow" together. The quality of the cold joint is additionally improved by the rough interface created by the cutter wheels overcutting the old panel (Fig. 5).
